Case report

Constrained implant dislocation in total hip replacement. Report of a case

Angeles del Pedregal Hospital

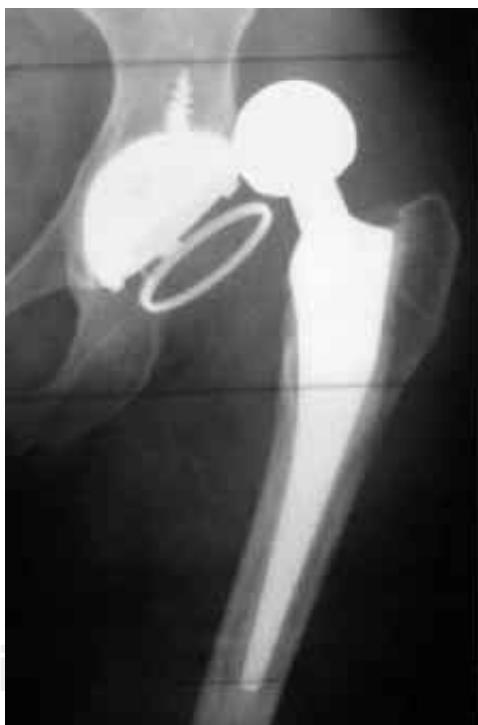
Figure 1. Dislocation of constrained hip prosthesis. Notice that the constrained polyethylene insert remains in place and the metal safety ring is intact. Inclination of the safety ring corresponds to the elevated lip of the polyethylene insert.

Over the following 9 months, the patient did not come again for postoperative control and suffered the dislocation of the constrained implant after having fallen from about a 1 meter height in March 2003. Interestingly the dislocation occurred when the femoral head of the polyethylene insert was dislodged in spite of the metal ring (acting as a latch for the constrained component) remaining in place (*Figure 1*). It was necessary to perform a new surgery where a pressure zone for the insert was found and where the femoral neck had a pinching effect with forced flexion of the joint. The acetabular cup was not modified and the constrained insert was replaced for a new component with the same features.

Five weeks after the surgery, the patient presented a third dislocation of the constrained component with the same characteristics: dislocation between the femoral head and the constrained polyethylene insert sparing the metal safety ring. In spite of the fact that the acetabular cup placement and fixation were acceptable, it was felt to be slightly neutral (not anteverted). This might have been a conditioning factor of the previous pinching effect between the polyethylene insert and the femoral head. The decision was to revise it. The new acetabular cup was placed at approximately 35° anteversion and 45° abduction. This time, we decided to place the standard, non constrained polyethylene insert. It still produced a pinching effect with the femoral neck on the ends of the arches of motion (*Figure 3*). With the standard insert, and once the joint was reduced, we got an excellent, very stable arch of motion. However, it was not possible to rebuild the articular capsule or reinsert the trochanter musculature which had already been previously documented. In spite of such stability, we insisted with the patient on the need for using a hip abductor device and limb weight bearing was deferred.

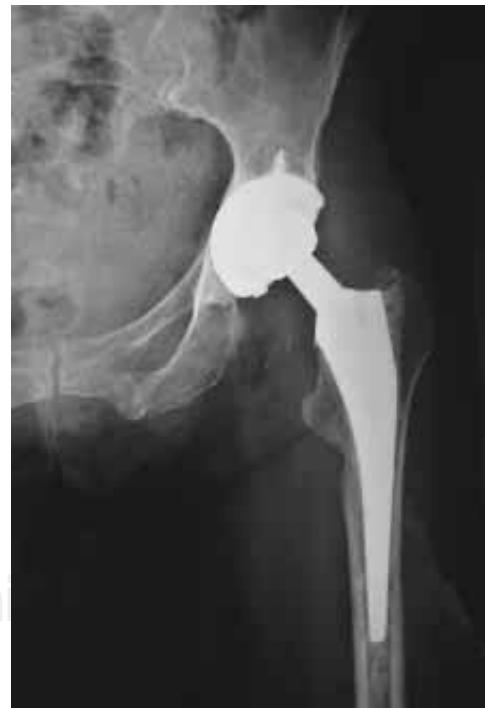
Figure 3. Postoperative X rays showing the placement of a standard acetabular implant. The femoral stem was not revised.
