Vol. 1, No. 2, April-June 2019

Clinical case

Acute dislocation of a Perceval valve treated with TAVI valve-in-valve: a literature review and case report

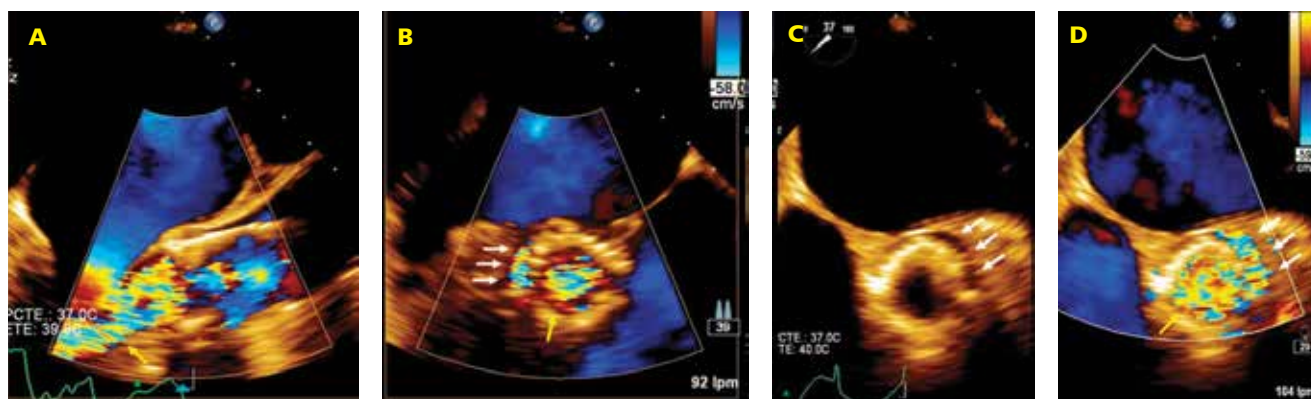
Figure 2: Transesophageal echocardiogram. **A)** Long axis: severe central aortic regurgitation (yellow arrow). **B)** Short-axis: severe central aortic regurgitation (yellow arrow) and paravalvular leak (white arrow). **C)** Short-axis view: dehiscence of the valve corresponding to the dislocated valve (white arrow). **D)** Short axis: severe paravalvular leak (yellow arrow) and central aortic regurgitation (white arrow).

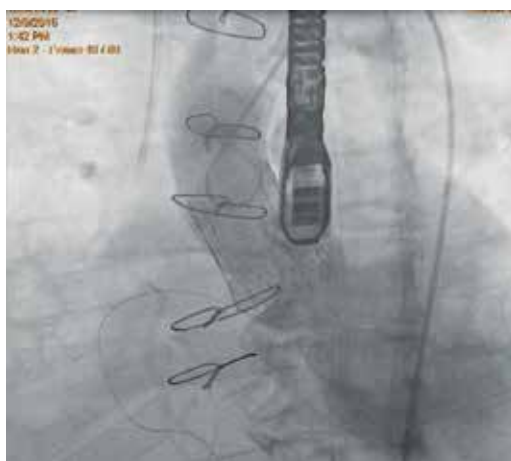
Video 1:

Fluoroscopy
diagnosis of
Perceval valve
dislocation.

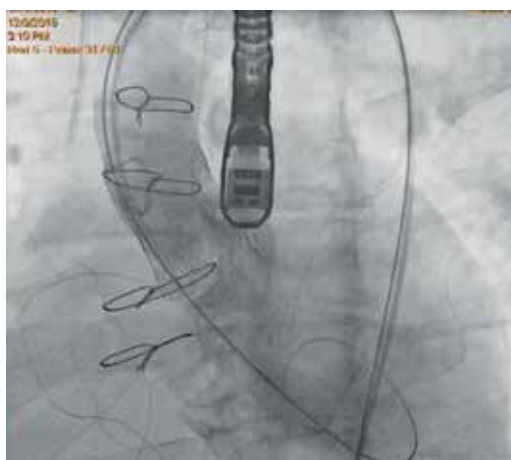
Video 2:

Super stiff guidewire
throw the Perceval
valve inside the left
ventricle.

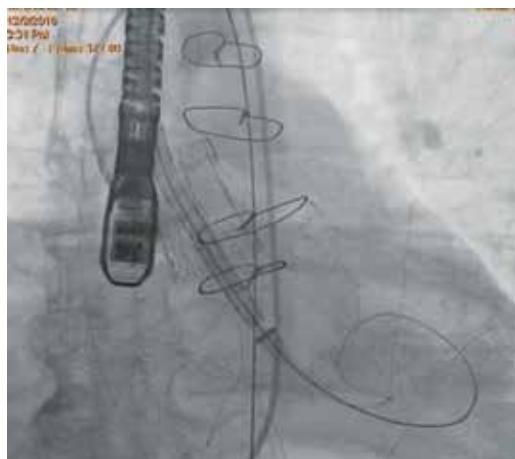
Video 3:

Move forward of the 29 mm CoreValve towards the aortic annulus.

determine the «new» left ventricle outflow tract a CoreValve 29 mm was selected for the implant.

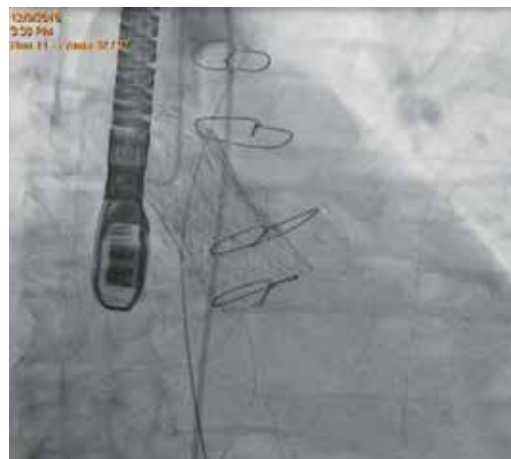
Video 5: Functional TAVI-ViV of the CoreValve 29 mm.
www.medigraphic.com/videos/ciu/192_5

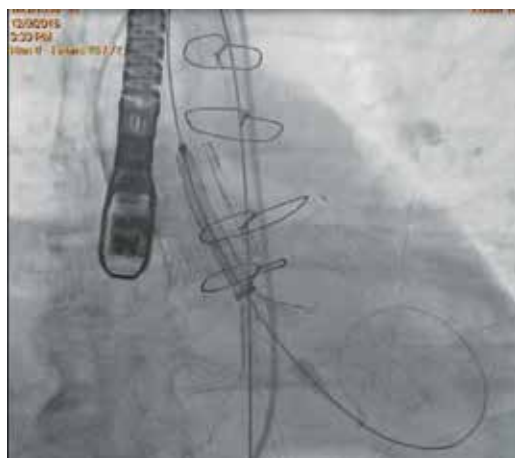
Video 4:

Release of 29 mm CoreValve.
