## CASE REPORT

A Fiberglass and Resin Post Technique Combined with Fragment Collage of an Upper Central Incisor: Multidisciplinary Treatment

Juan Carlos Ramírez Barrantes DDS, MSD, PhD<sup>1</sup>

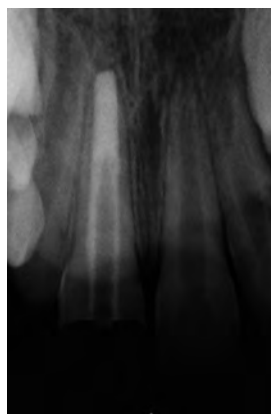
**Figure 6.** The radiograph shows the post in position and the adaptation of the composite resin to the dentinal walls.

After photopolymerization, the standard post was removed with pliers, an exact conformation for glass fiber post # 2 Luminex System - Luscent Anchors™ (Dentatus) was observed. Subsequently, the glass fiber post was siliconized with RelyXMR silane agent (Scotchprimer silane; 3M ESPE), and then cemented with RelyX™ ARC (3M ESPE). The polymerization of the resin cement was performed by applying the LED light for 40 s. All materials were used in accordance with the recommendations and working times suggested by the manufacturers (Figure 5). A periapical radiograph was taken after the completion of cementation of the post, including checking the adaptation and length within the root canal (Figure 6).

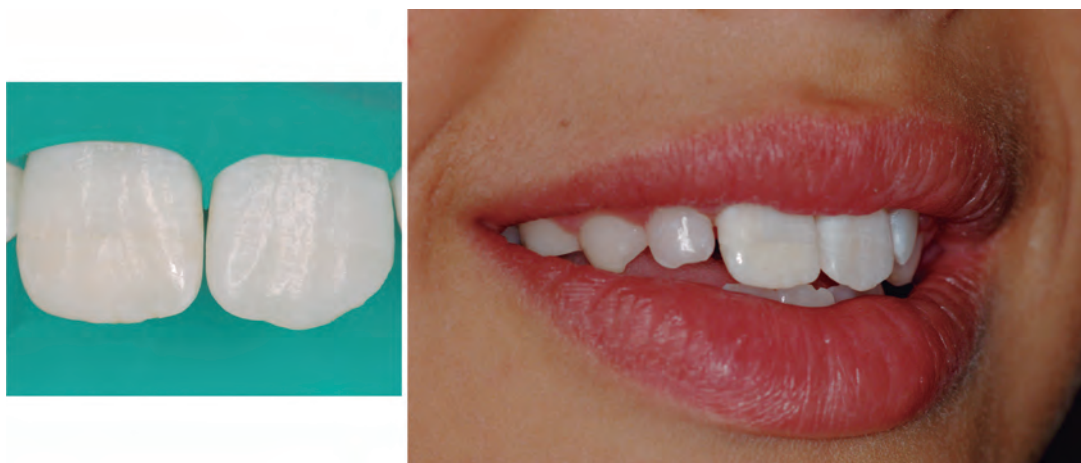
**Figure 8:** Final evaluation to check the fragment aesthetics. The bond line was practically imperceptible.

restoration was performed after 72 hours of treatment. The importance of confection and the use of the night splint was explained to the patient (Figure 8).
